**CONSENT ORDER
ISSUED UNDER THE
WATER POLLUTION CONTROL ACT
WEST VIRGINIA CODE, CHAPTER 22, ARTICLE 11**

TO: MarkWest Liberty Midstream & Resources, L.L.C. DATE: March 28, 2019
Gregory Bezdek, SVP, NE Region
4600 J Barry Ct. Ste 500
Canonsburg, PA 15317 ORDER NO.: 8945

MARKWEST LIBERTY MIDSTREAM & RESOURCES, L.L.C, WVR311004, Sherwood to Mobley
20" NGL, 8/22 & 8/23/2018

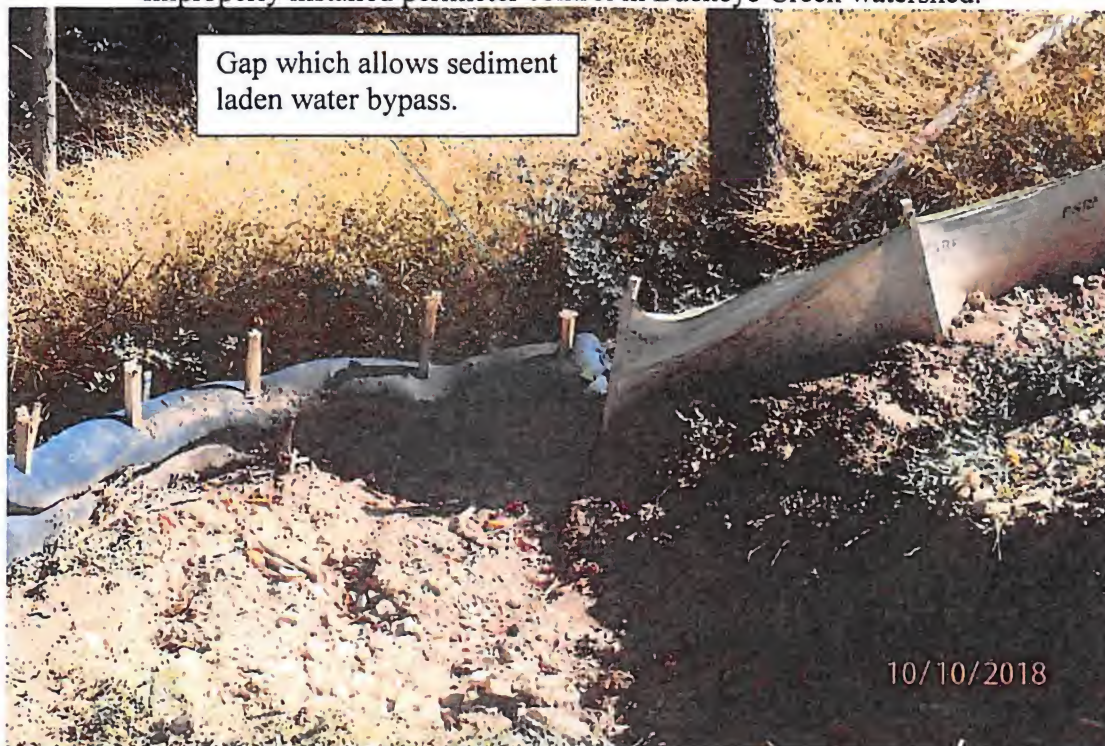
Improperly installed perimeter control in Buckeye Creek watershed.

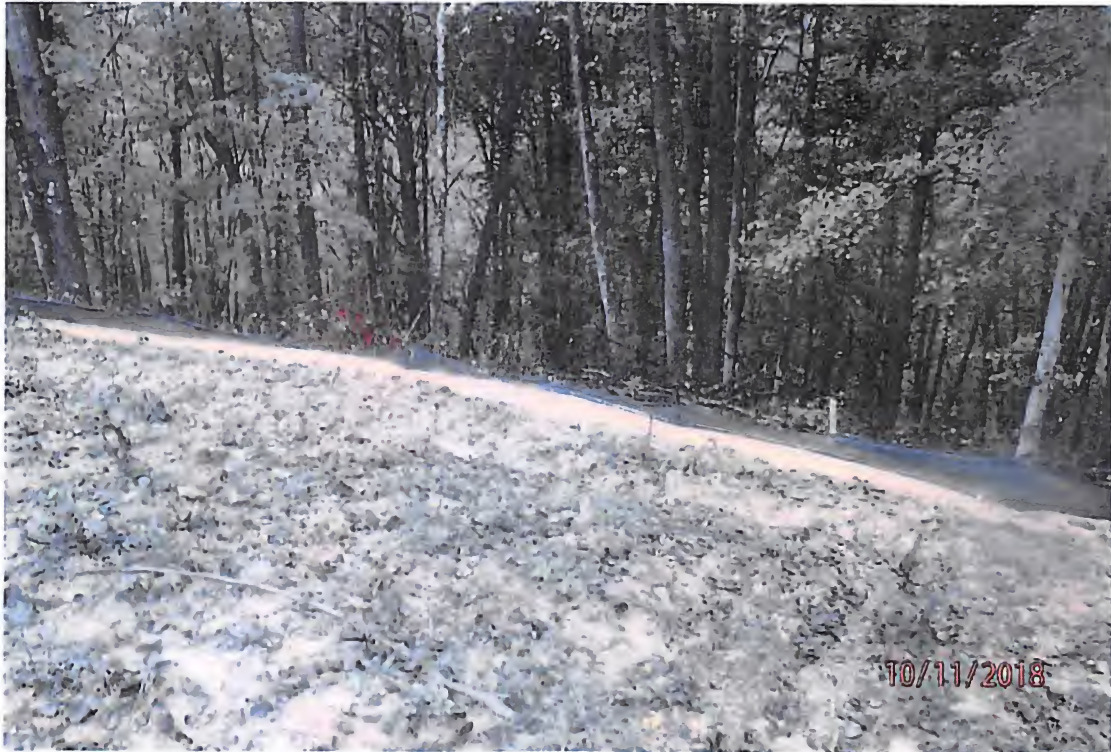
Concentrated flow stormwater following perimeter controls as a result of poorly constructed water bars near 820+00.

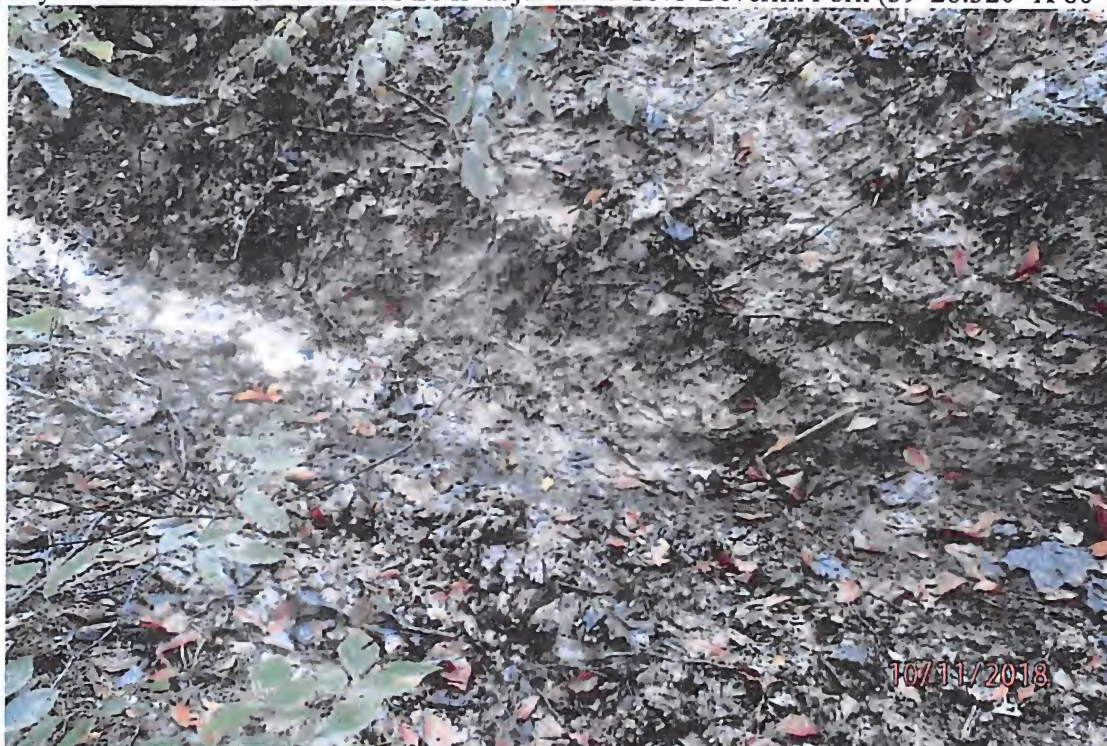
Improperly installed water bar terminus BMP adjacent to UNT Beverlin Fork (39°26.320' X 80°36.101')

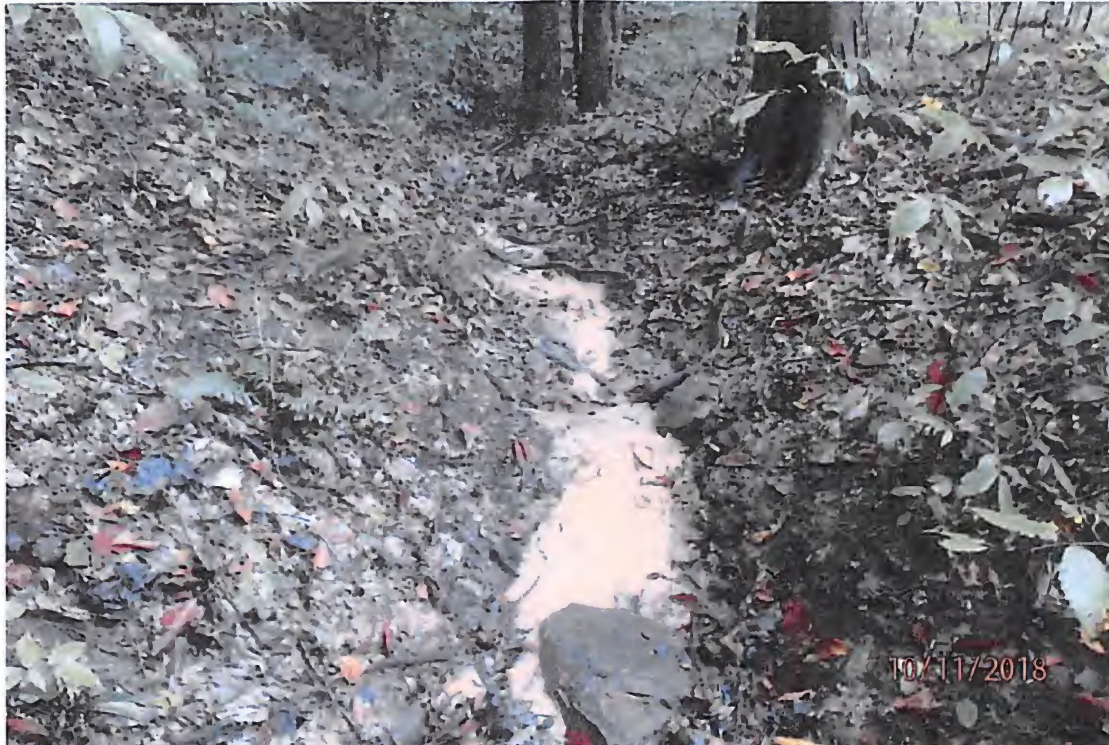
CNA distinctly visible settleable solids in UNT Beverlin Fork (39°26.320' X 80°36.101').

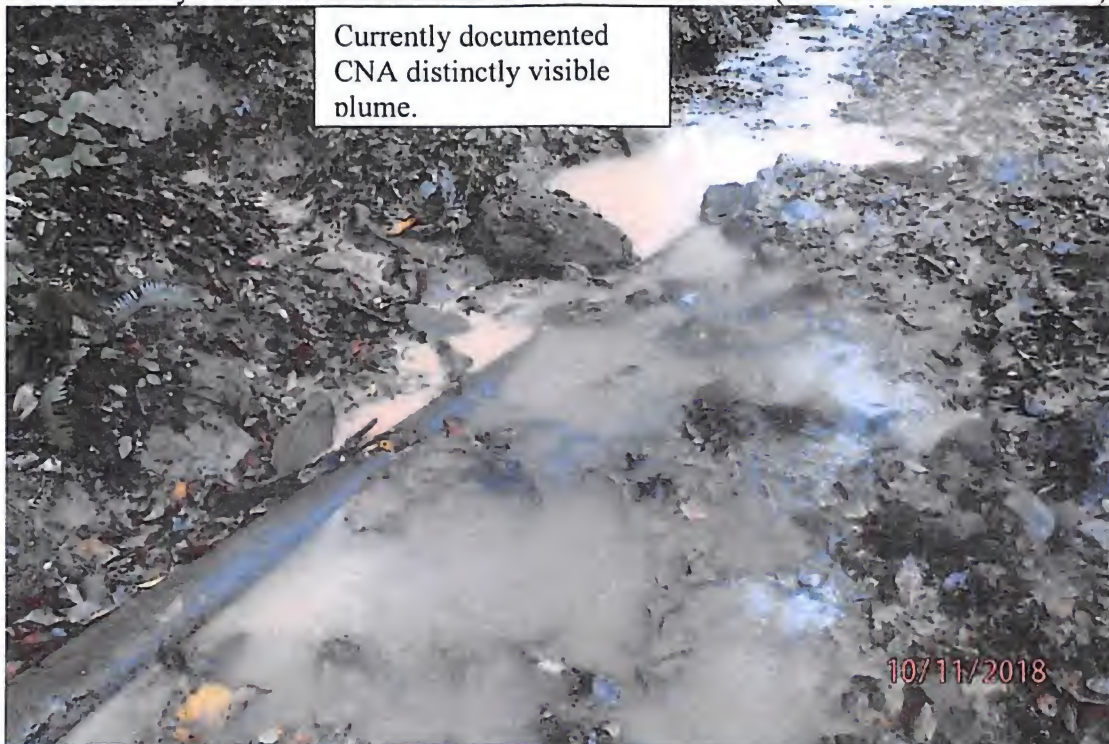
CNA distinctly visible settleable solids in UNT Beverlin Fork (39°26.320' X 80°36.101').

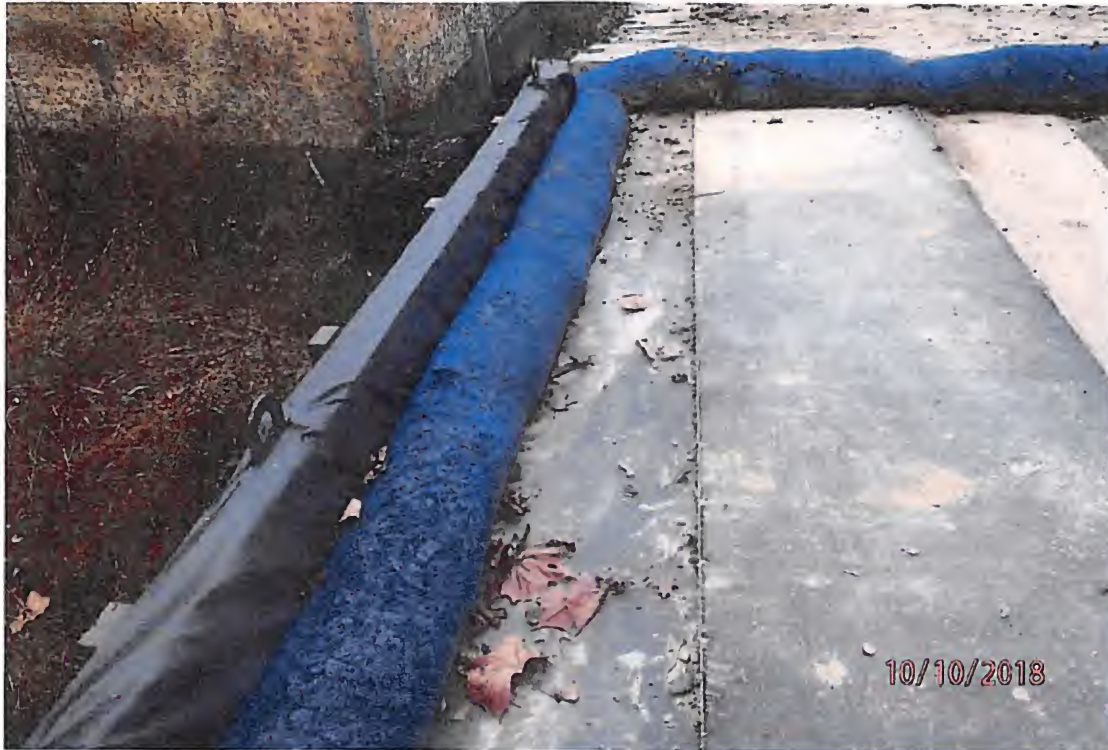
CNA distinctly visible settleable solids in UNT Beverlin Fork (39°26.320' X 80°36.101').

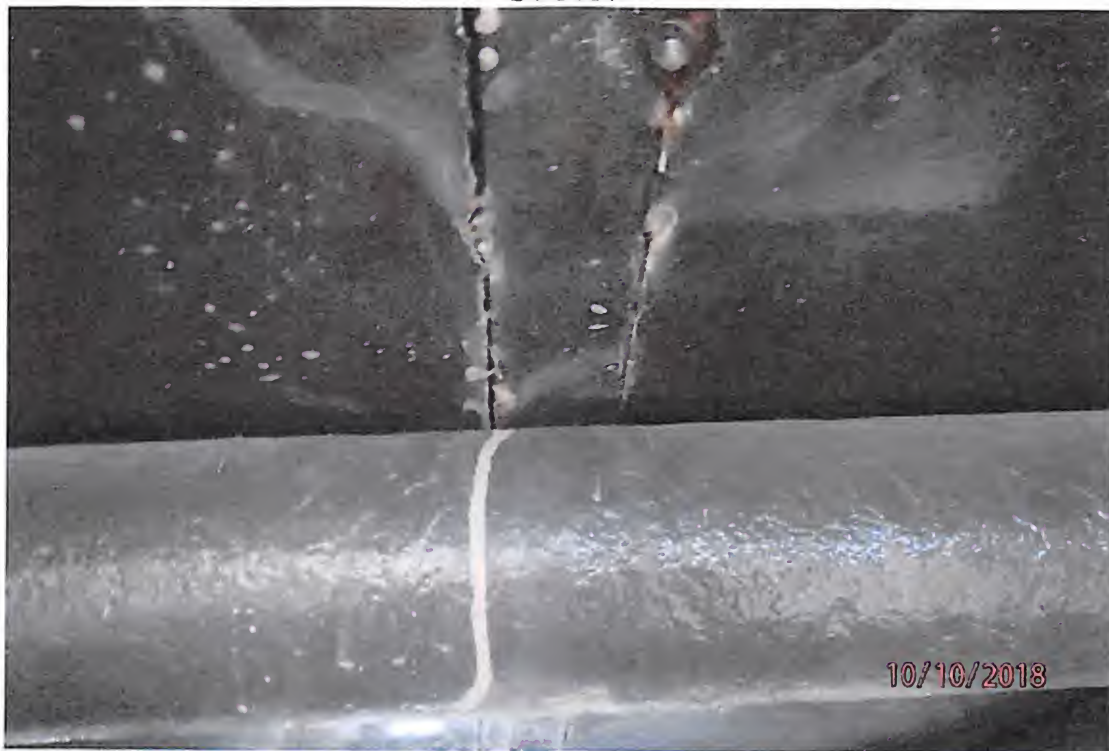
Installed bridge at crossing # 48 that lacks the top layer of timber mats as indicated in the approved SWPPP.

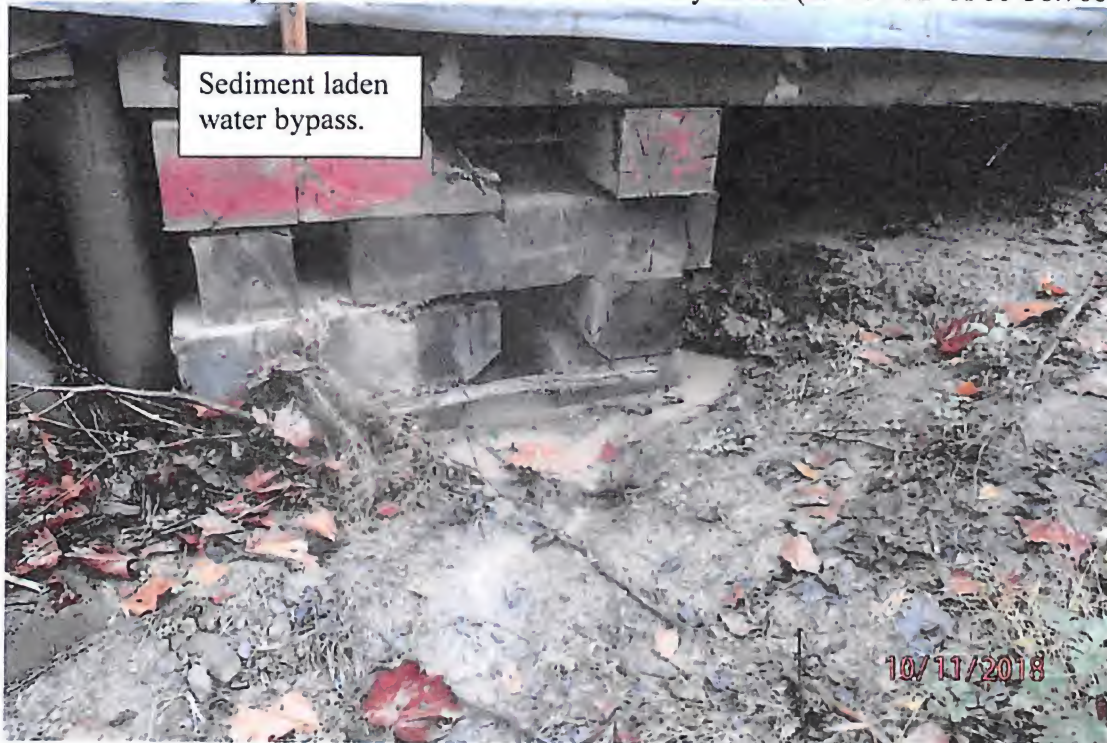
Installed bridge at crossing # 54 that lacks the top layer of timber mats as indicated in the approved SWPPP and is in need of maintenance. Bridge allowed sediment laden water to bypass the device and caused CNA distinctly visible settleable solids in McElroy Creek (39°23.952' X 80°38.768').

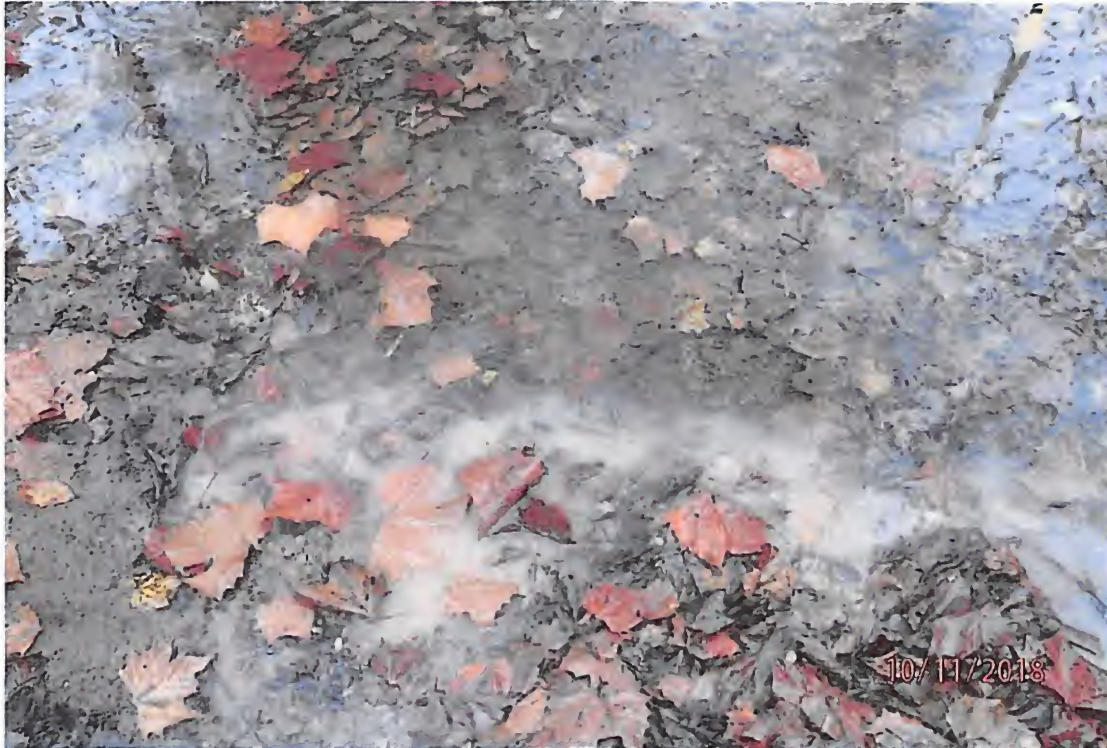
Above pictured bridge showing sediment laden water bypass.

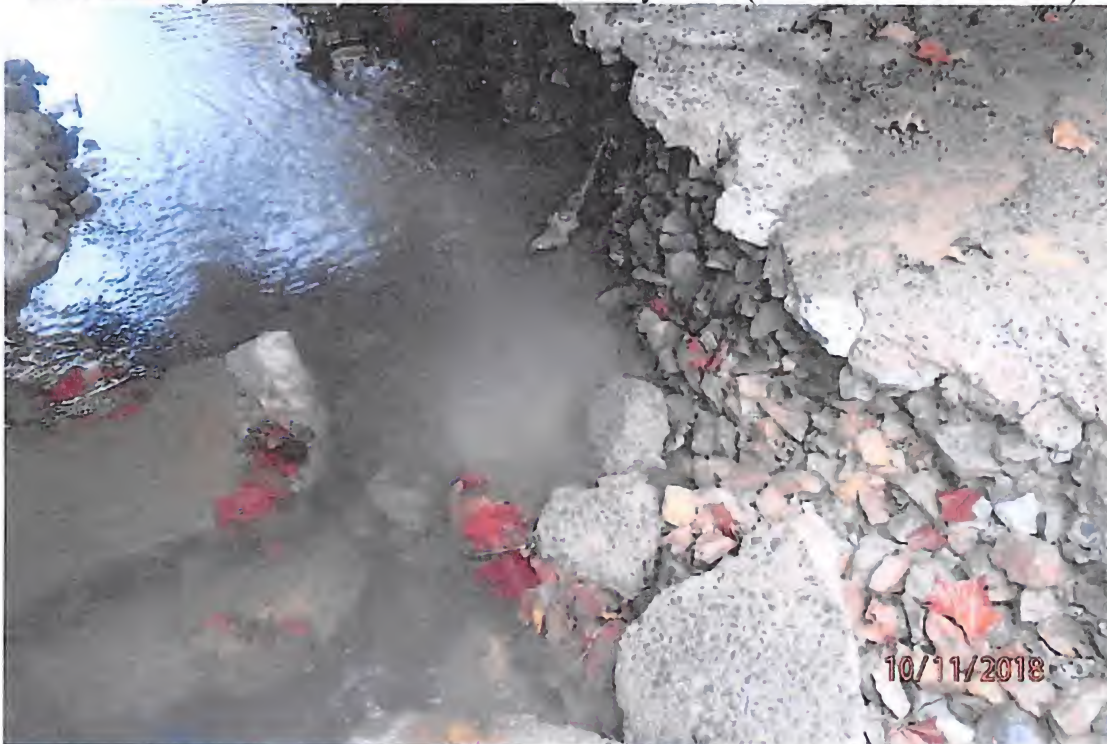
CNA distinctly visible settleable solids in McElroy Creek (39°23.952' X 80°38.768').

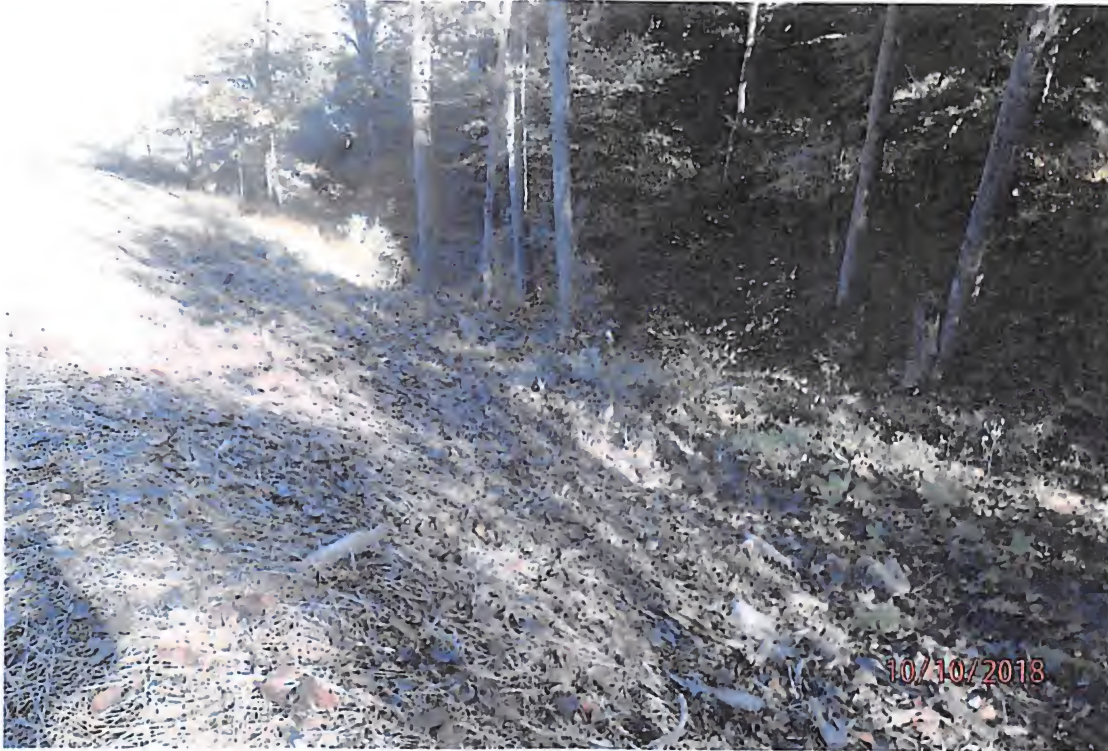
CNA distinctly visible settleable solids in McElroy Creek (39°23.952' X 80°38.768') as a result of the bridge at crossing # 54.

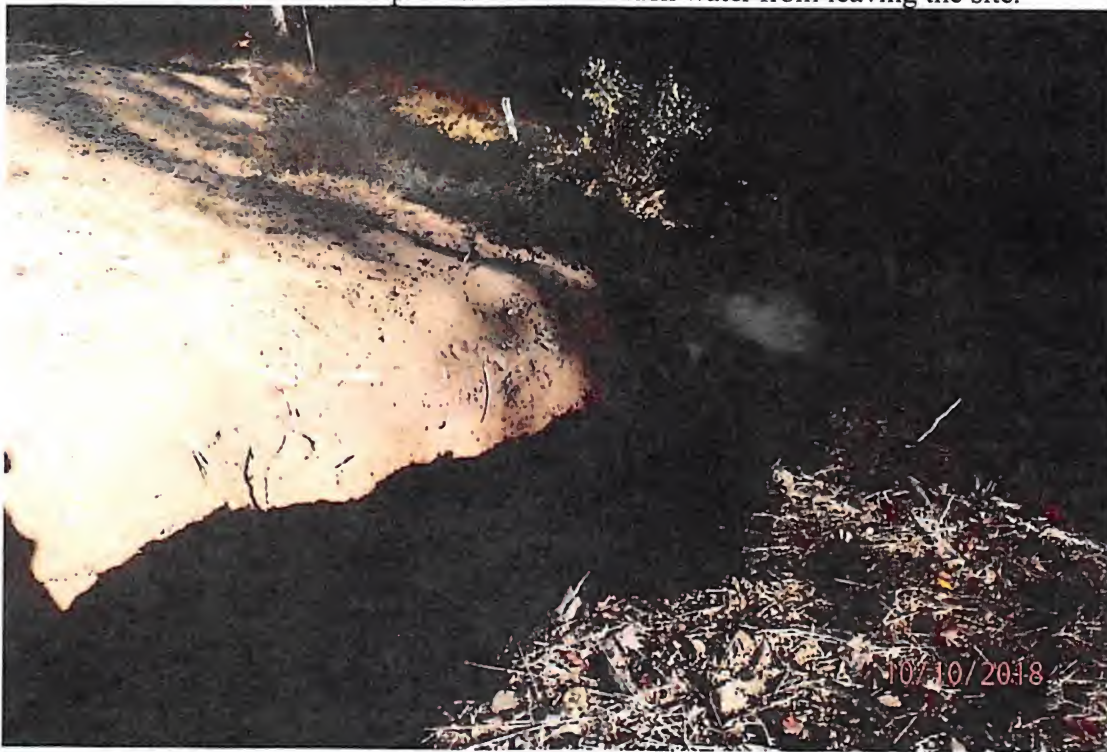
Area adjacent to 142+00 where BMPs are not indicated in the approved SWPPP and the SWPPP needs to be modified in order to prevent sediment laden water from leaving the site.

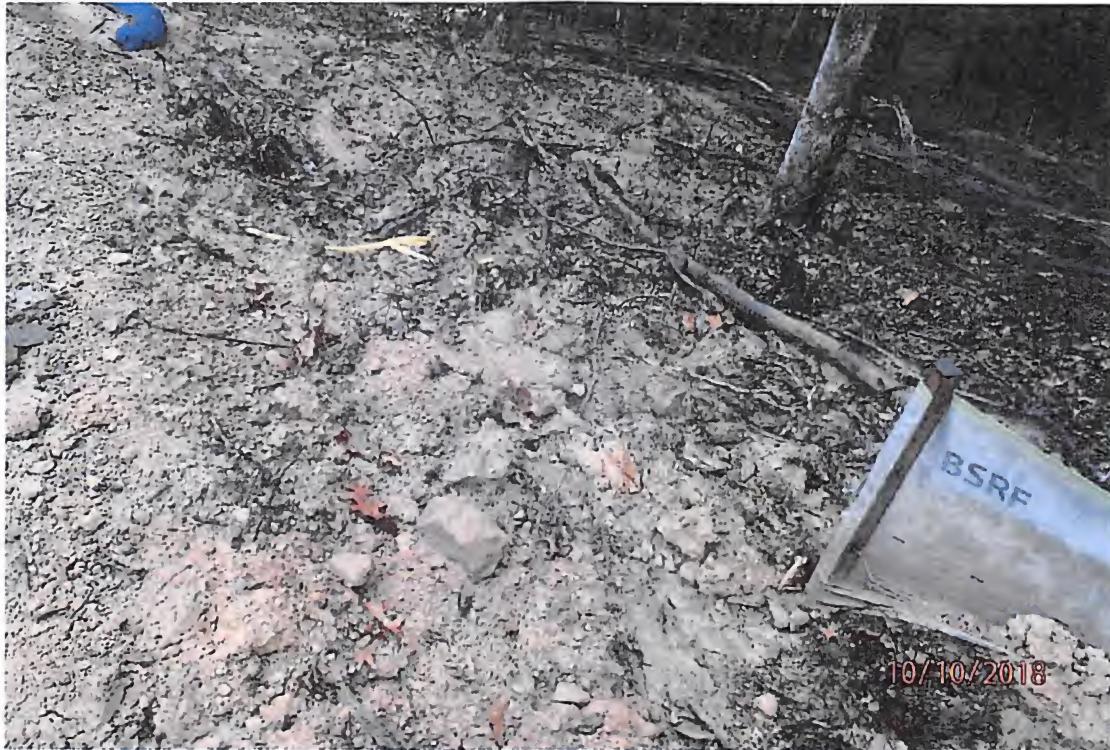
Area adjacent to 142+00 where BMPs are not indicated in the approved SWPPP and the SWPPP needs to be modified in order to prevent sediment laden water from leaving the site.

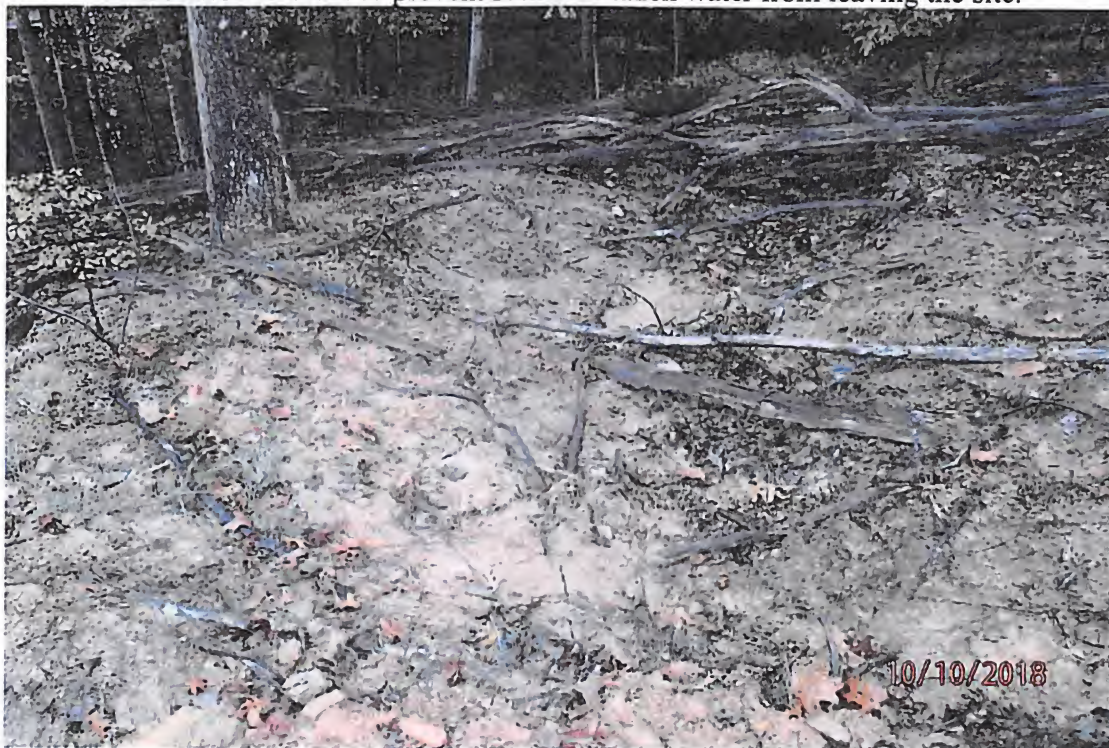
Area adjacent to 415+00 where BMPs are not indicated in the approved SWPPP and the SWPPP needs to be modified in order to prevent sediment laden water from leaving the site.

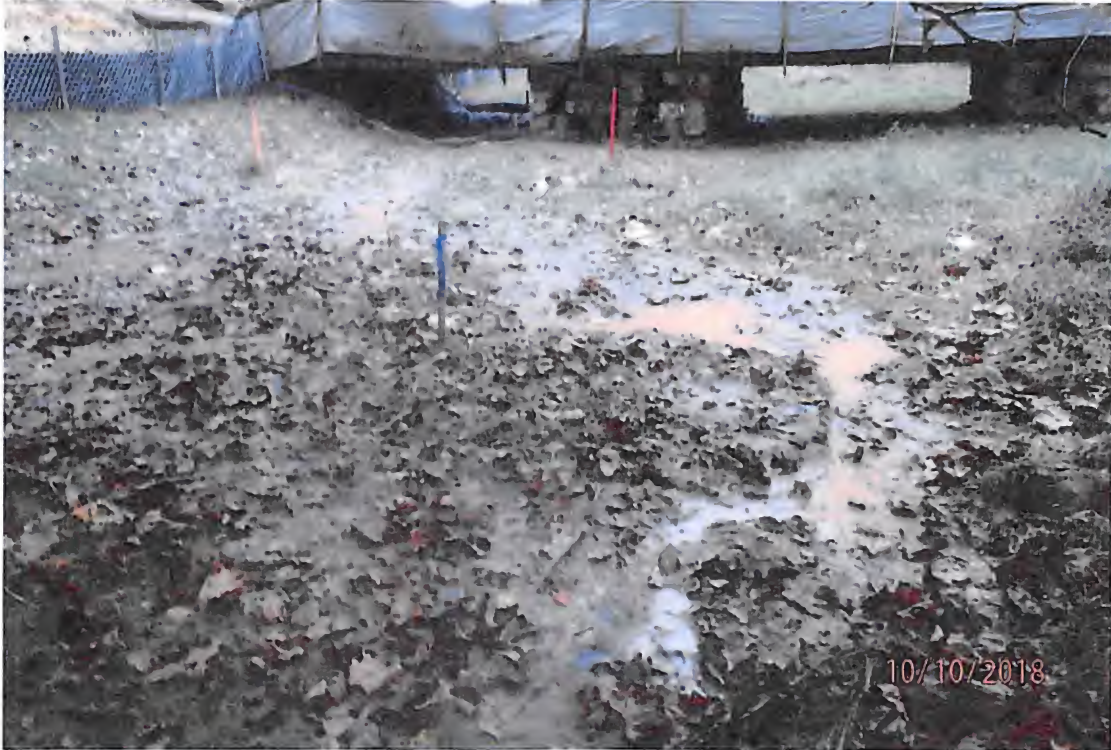
Offsite sediment deposits adjacent to 415+00.

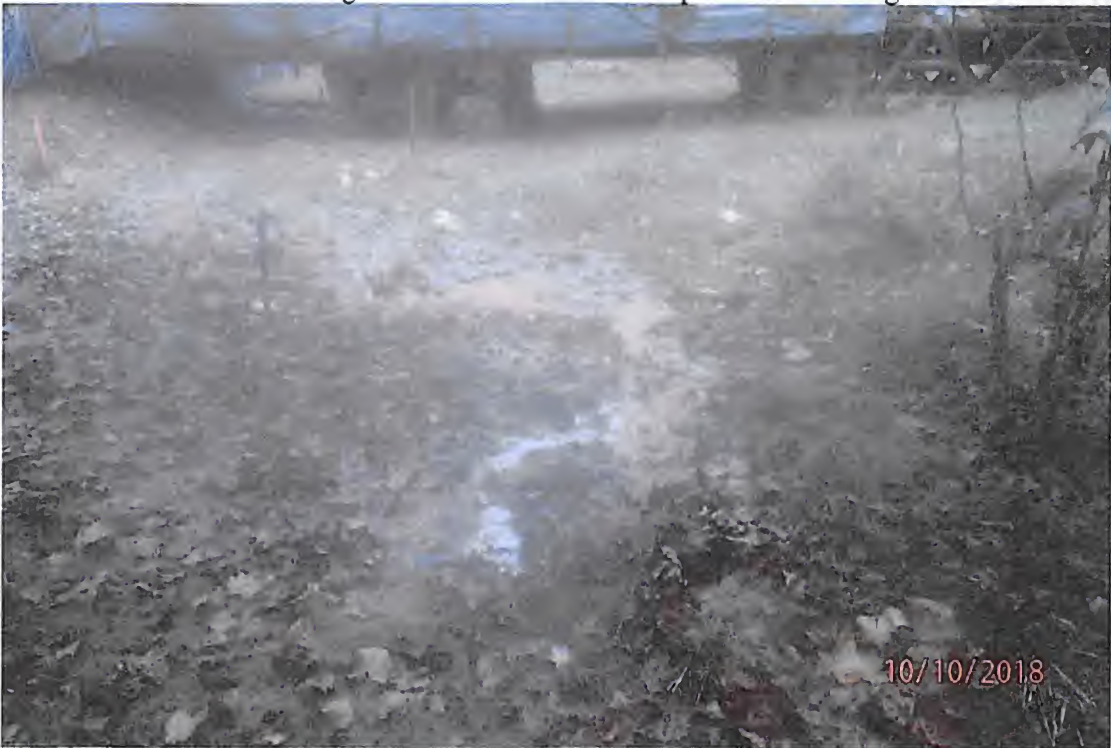
Area adjacent to UNT Riggins Run where the approved SWPPP does not indicate the need for a BMP and sediment laden water is leaving the site with no device in place and causing CNA in the stream.

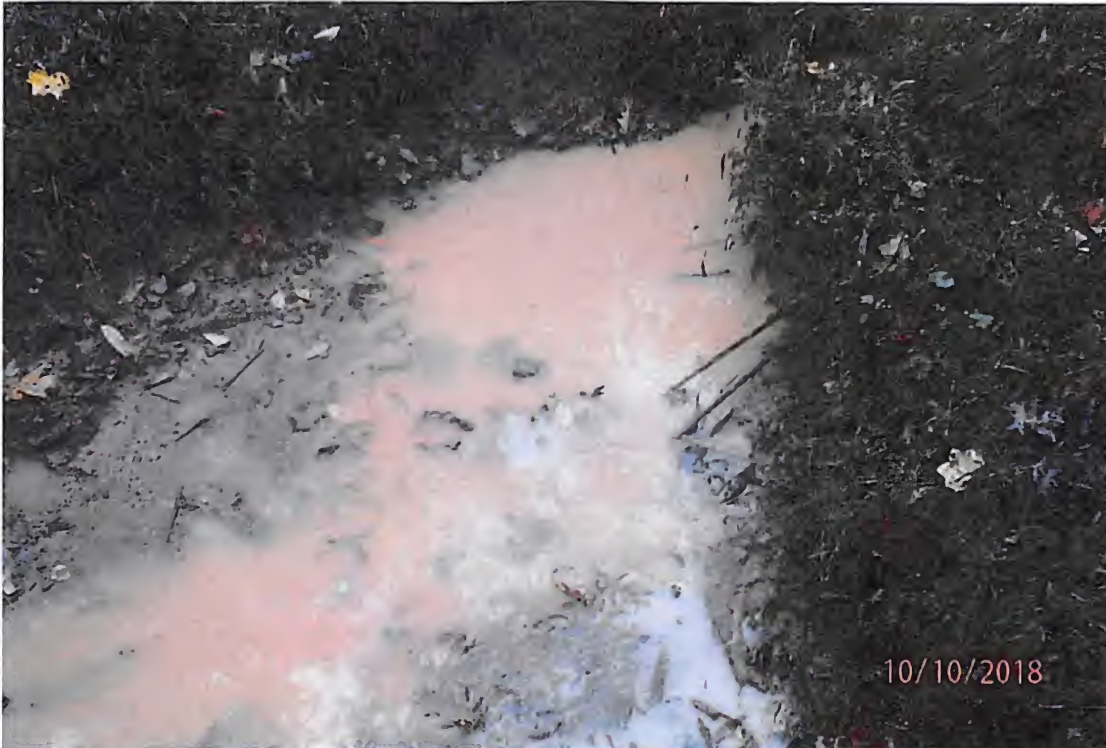
Area adjacent to UNT Riggins Run where the approved SWPPP does not indicate the need for a BMP and sediment laden water is leaving the site with no device in place and causing CNA in the stream.

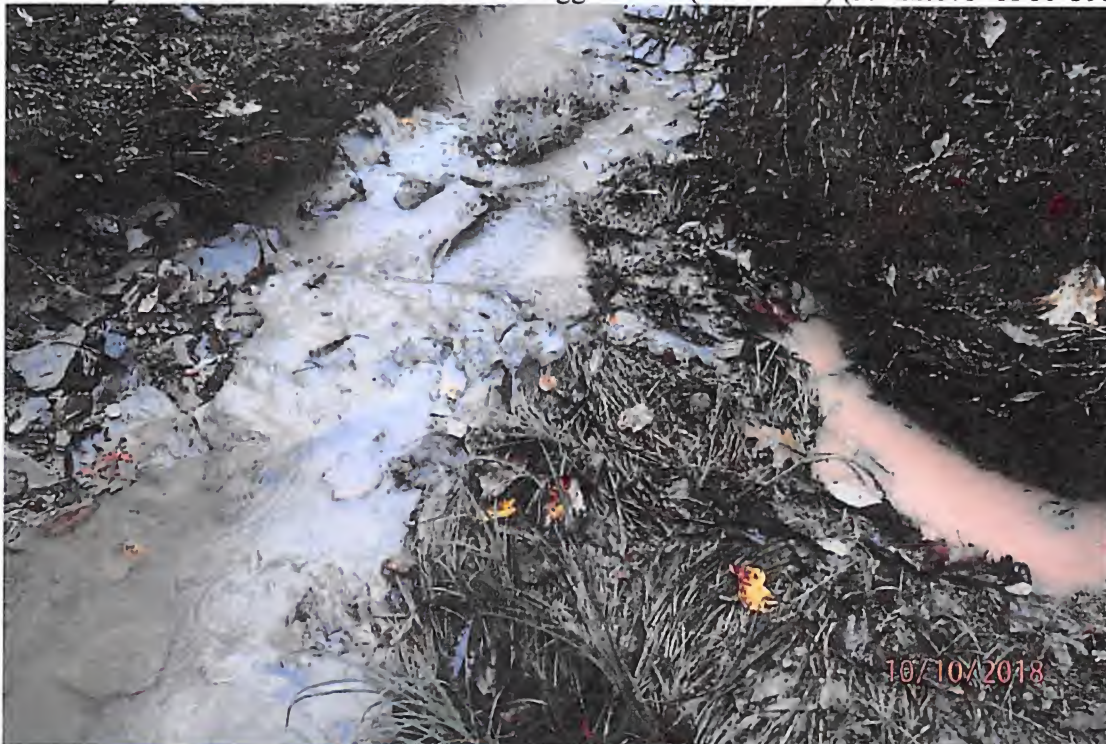
CNA distinctly visible settleable solids in UNT Riggins Run (UNT – 18) (39°22.075' X 80°39.463').

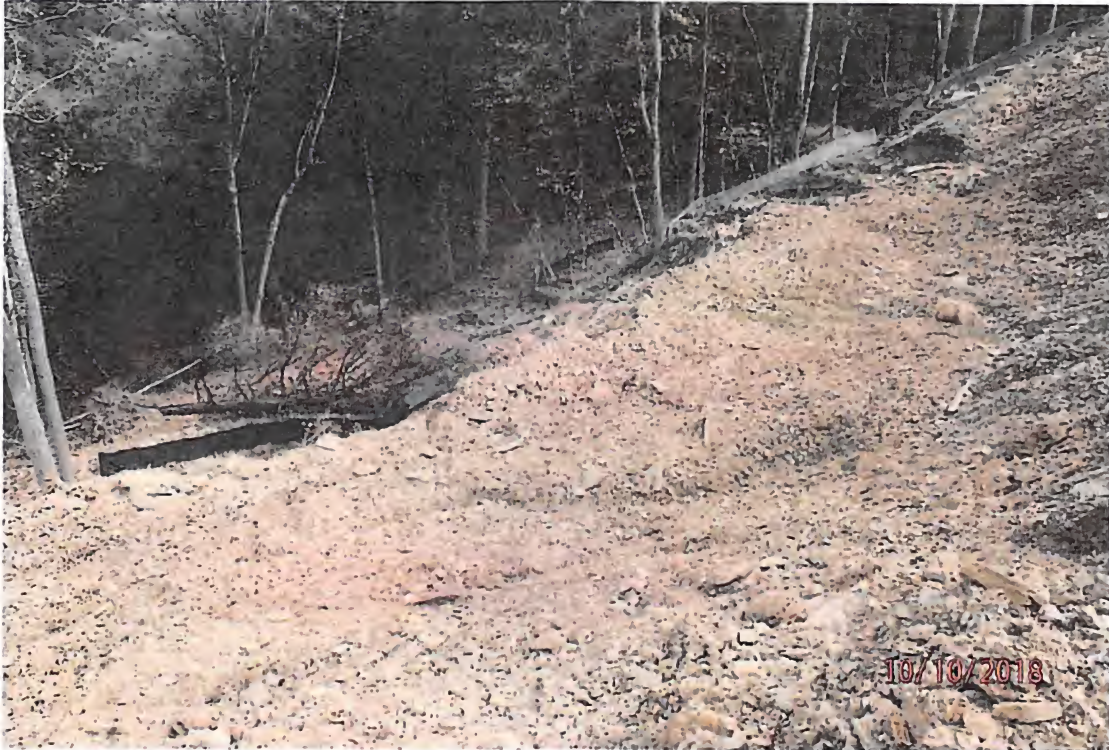
CNA distinctly visible settleable solids in UNT Riggins Run (UNT – 18) (39°22.075' X 80°39.463').

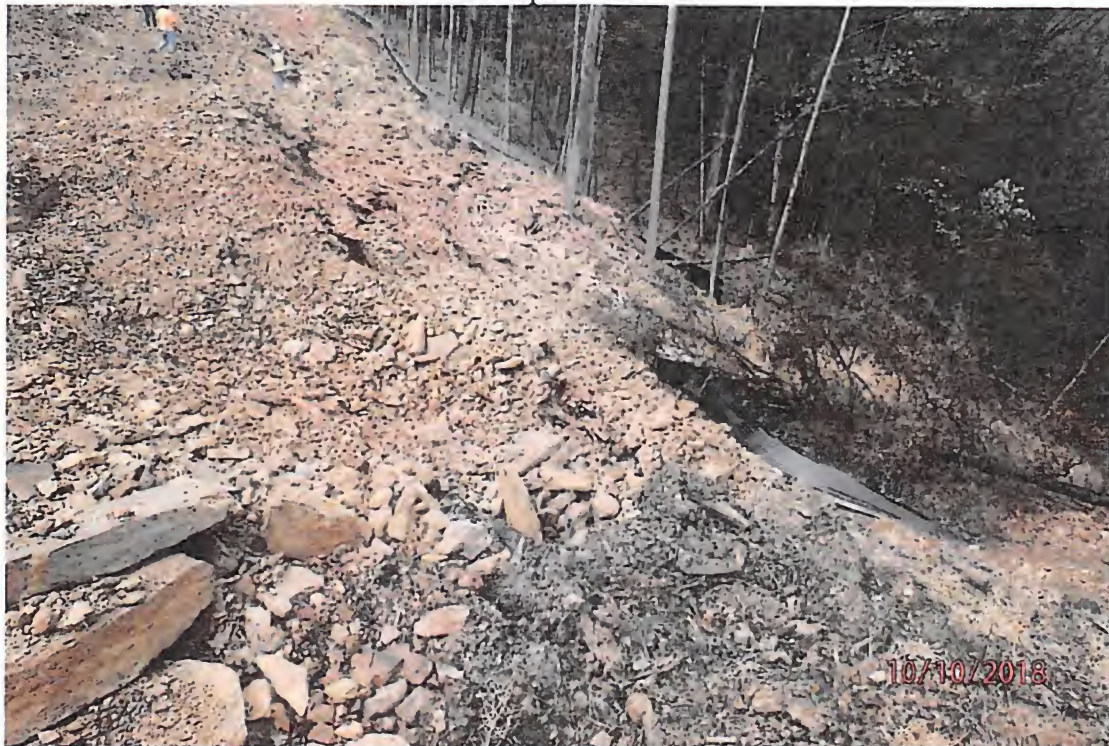
Offsite slip near 248+00.

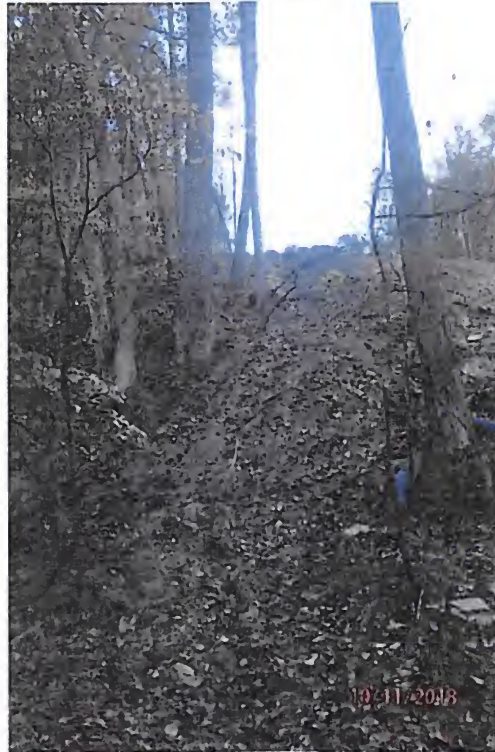
Offsite slip near 248+00.

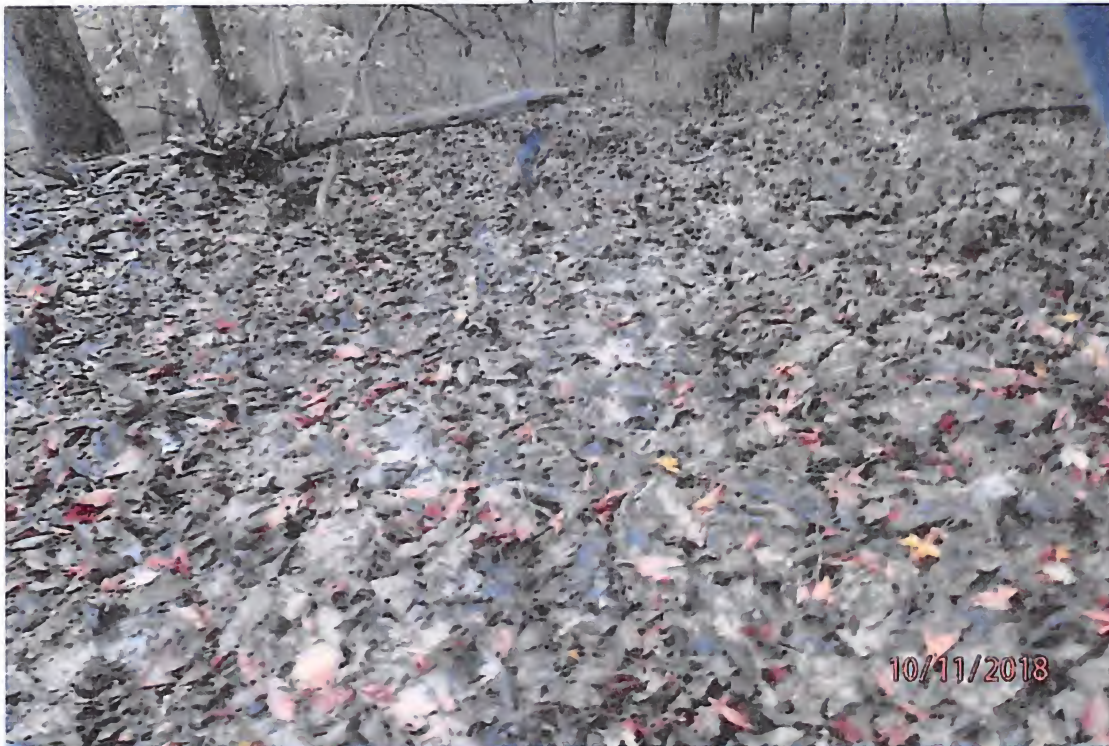
Offsite slip near 479+50.

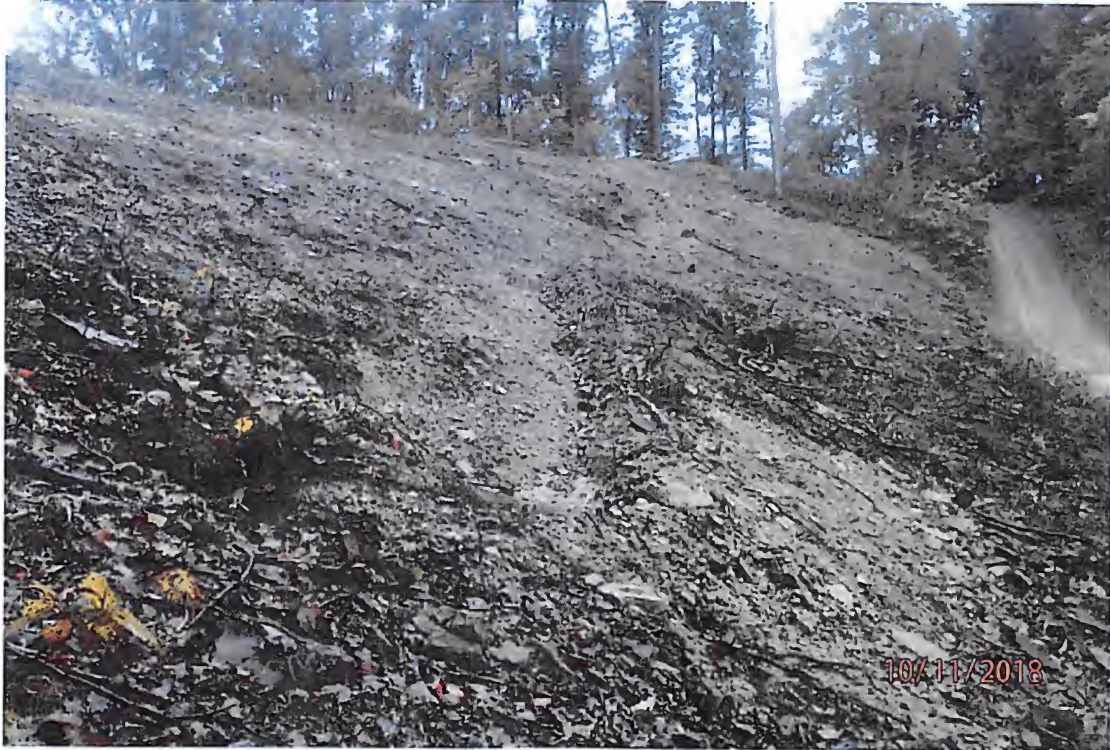
Offsite slip near 479+50.

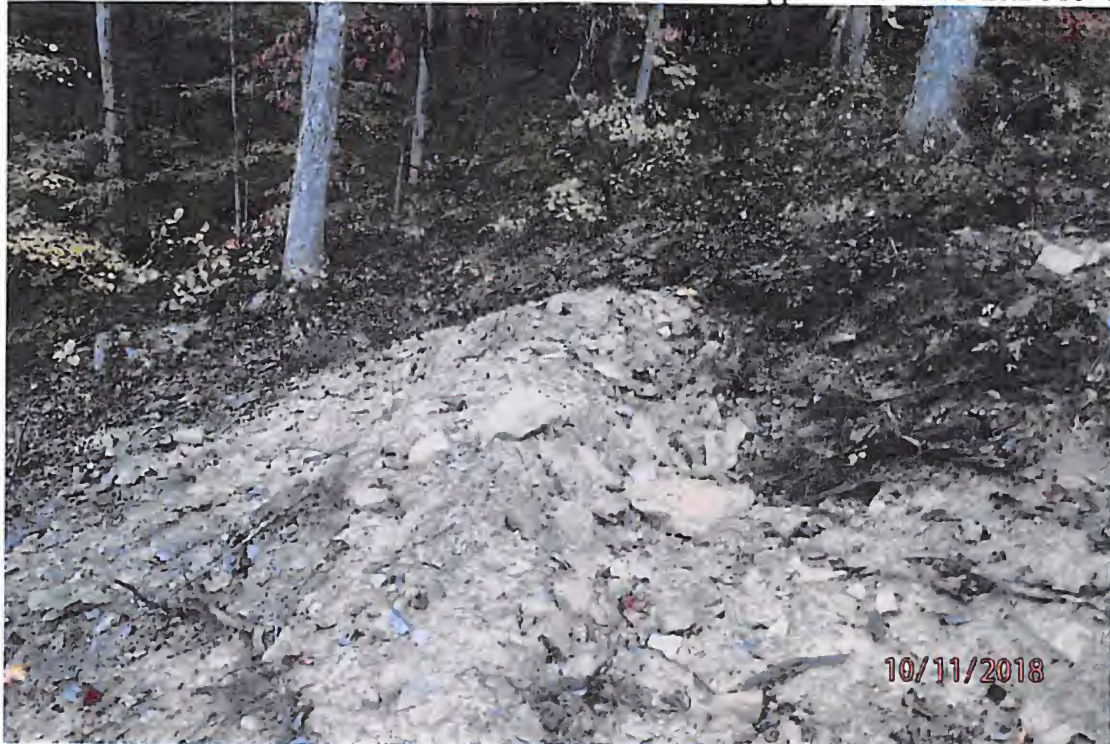
Water bar that lacks water bar terminus BMPs indicated in the approved SWPPP near 510+00.

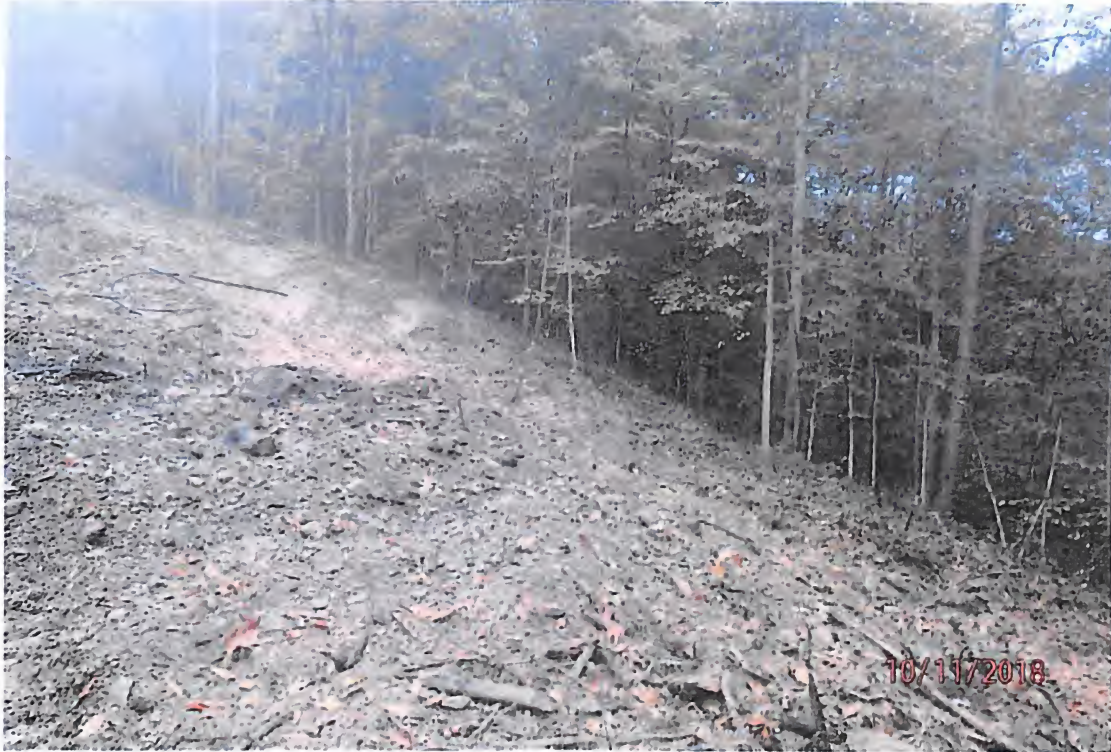
Water bar that lacks water bar terminus BMPs indicated in the approved SWPPP near 510+00.

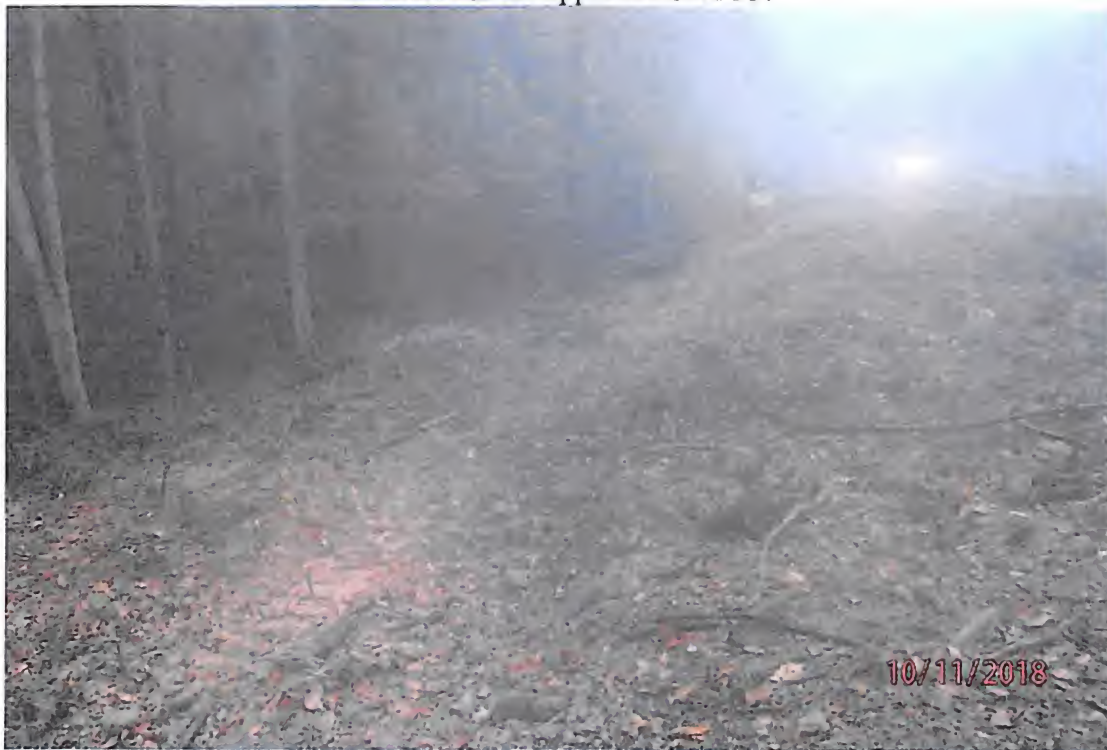
Area of disturbance from 561+00 to 588+00 that lacks water bar terminus BMPs and perimeter controls indicated in the approved SWPPP.

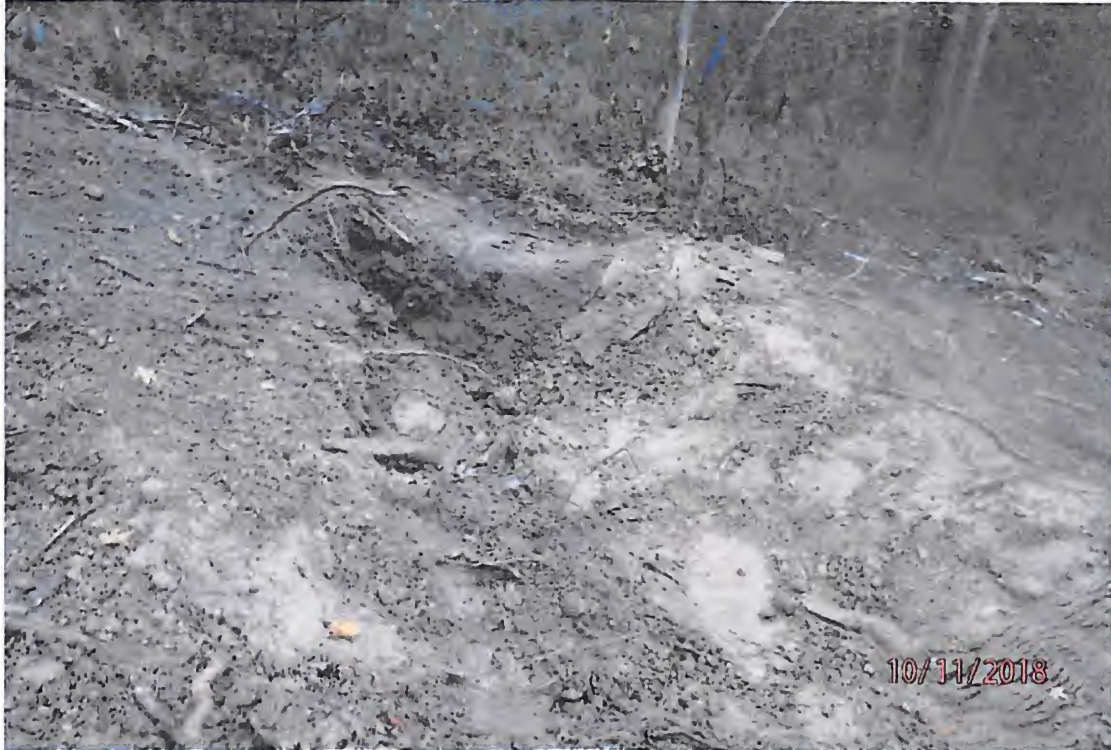
Area of disturbance from 561+00 to 588+00 that lacks water bar terminus BMPs and perimeter controls indicated in the approved SWPPP.
